Queensland University of Technology

Maximising Value and Minimising Costs

CLIENT PERSPECTIVE

CONSULTANT PERSPECTIVE

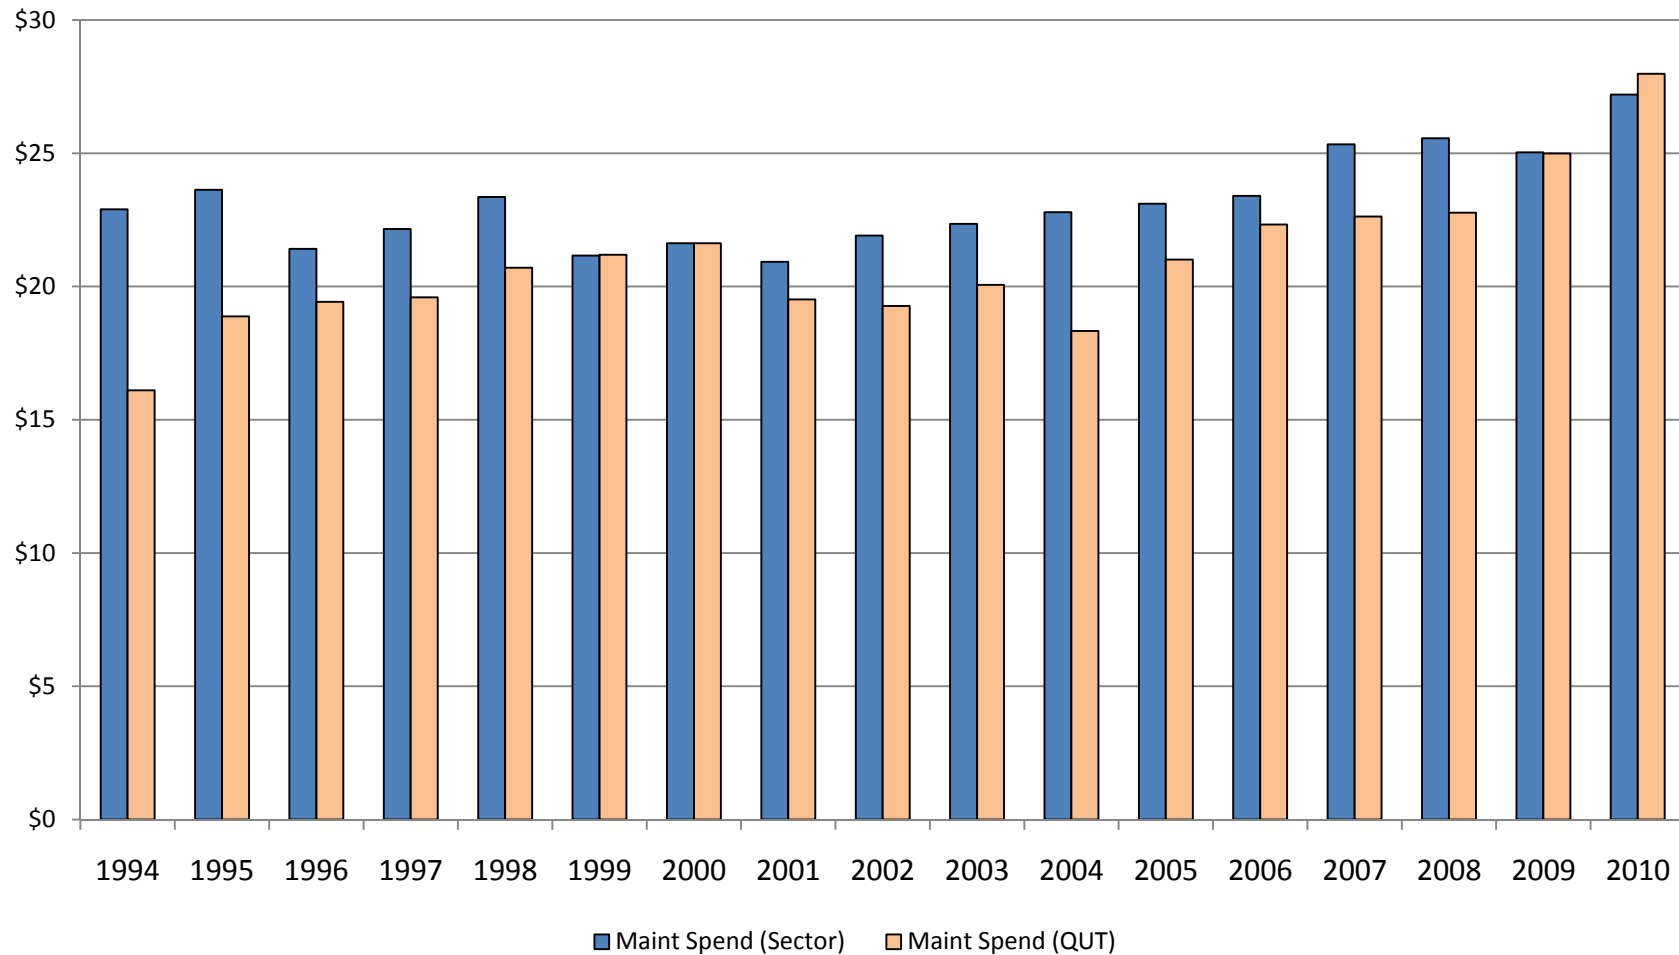
Maintenance Spend by Institution (%ARV)

Maintenance Spend (Sector)

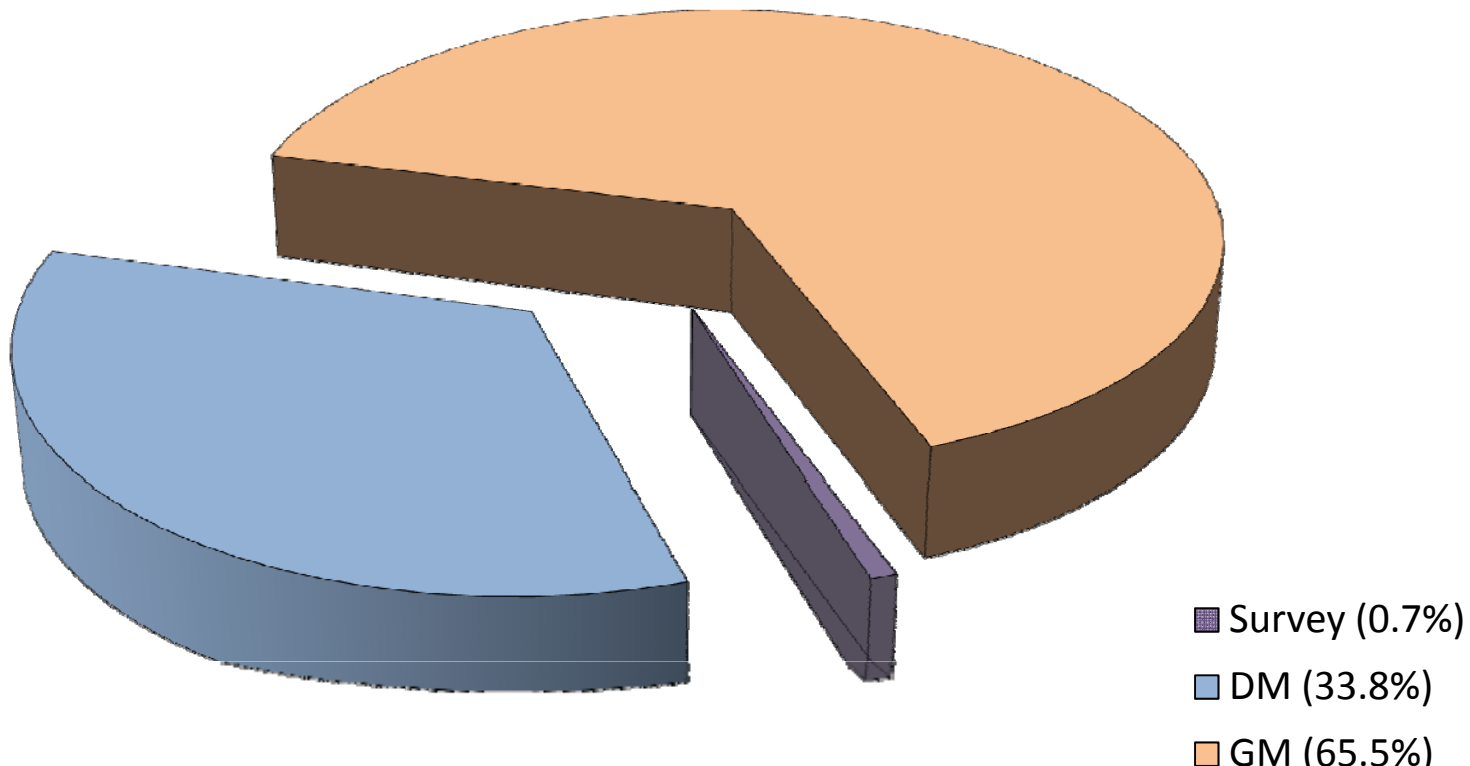
Relative Cost of Condition Survey

Cost of Facilities Condition Survey

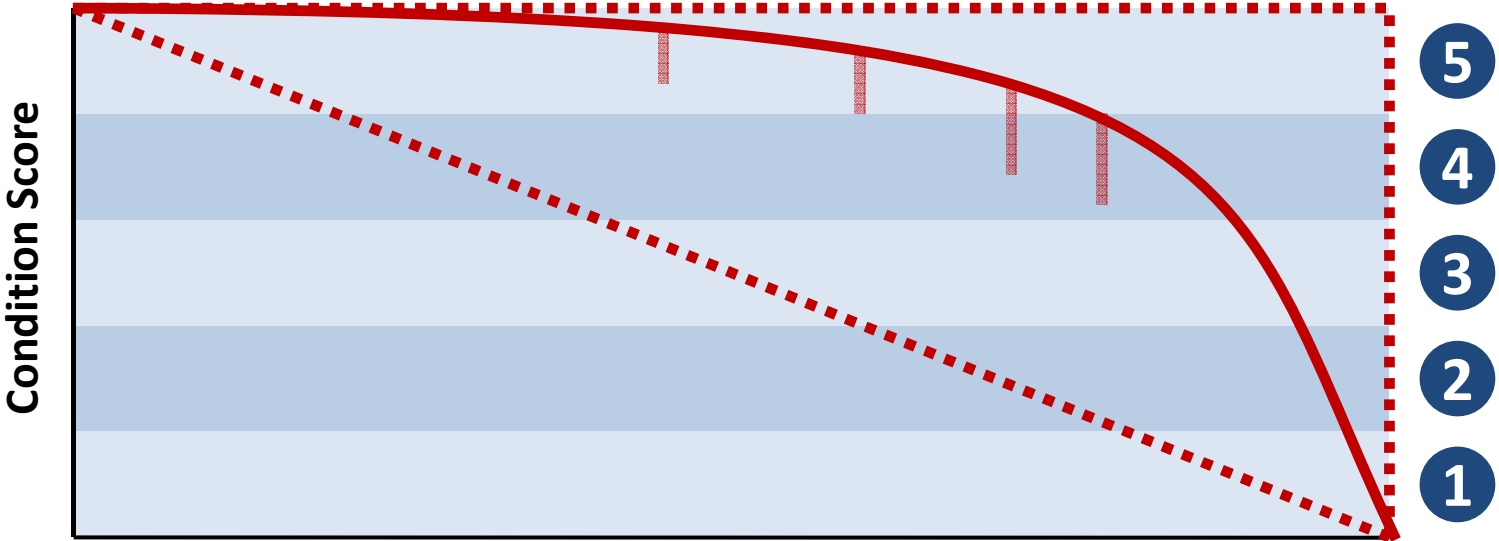
Condition Scale

1 (poor) to 5 (excellent)

Site specific

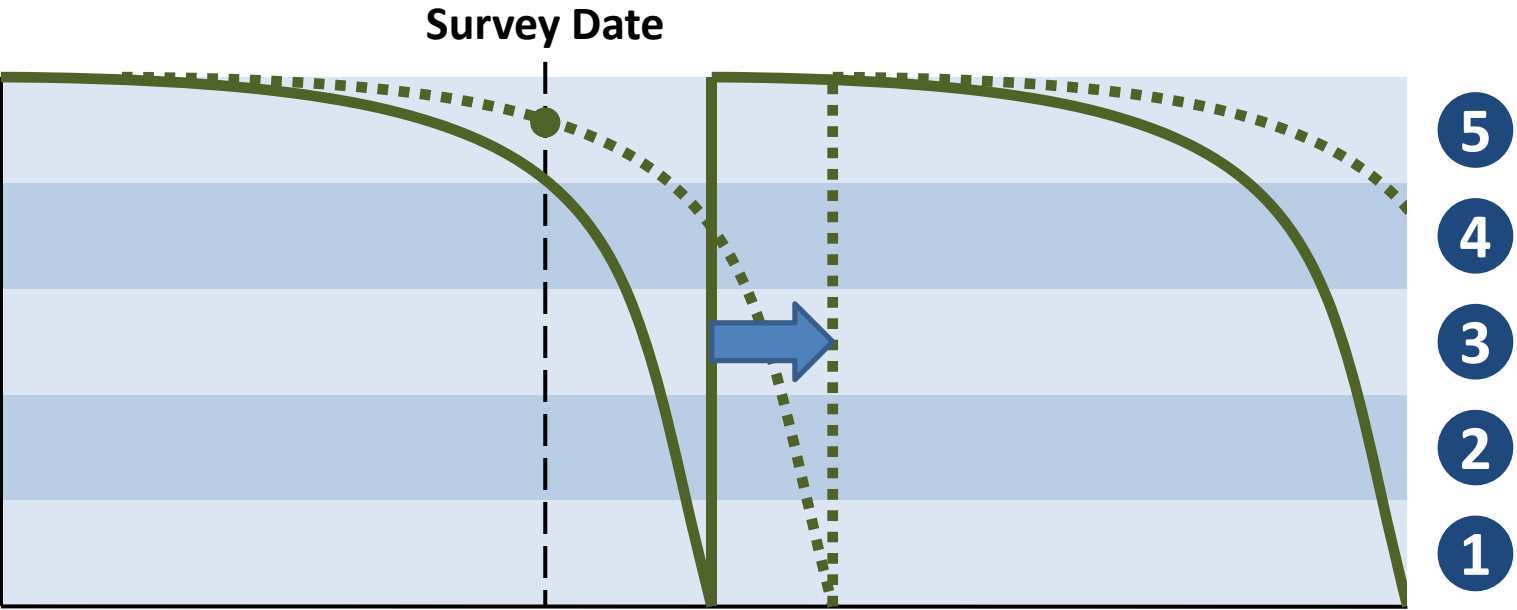
Remaining Life

Determined from condition, adjusted for sensibility
